SURVEY REPORT

Tanzer 7.5

SURVEY PARTICULARS

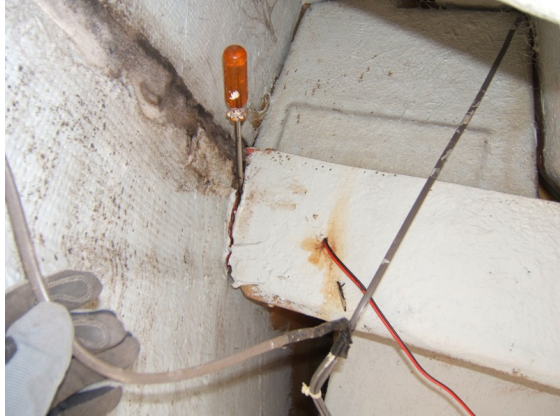
Main beam port side

Cabin liners of fibreglass hand laid woven roving, mat and gel coat. Sound and generally well secured to hull and deck. Exceptions “main beam” which was not connected to the hull port side and was partly separated on starboard side. {2} Not critical but recommend re-establish connections to extend the overall life of the boat.

{2} Cabin liners of fibreglass hand laid woven roving, mat and gel coat. Sound and generally well secured to hull and deck. Exceptions "main beam" which was not connected to the hull port side and was partly separated on starboard side. Not critical but recommend re-establish connections to extend the overall life of the boat.

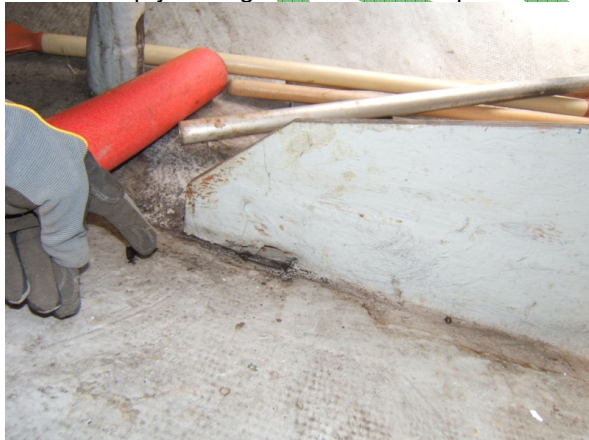
Aft end

Centreline plywood gusset under cockpit footwell. Slightly deteriorated at aft end and fiberglass tabbing let go at aft end. {3} Not critical but recommend remove deteriorated portion and replace with new and re-establish hull connections to maintain hull stiffening and extend the overall life of the boat.

{3} Centreline plywood gusset under cockpit footwell. Slightly deteriorated at aft end and fiberglass tabbing let go at aft end. Not critical but recommend remove deteriorated portion and replace with new and re-establish hull connections to maintain hull stiffening and extend the overall life of the boat.
